Brocade Fabric OS v6.4.2a Release Notes v3.0

August 19, 2011

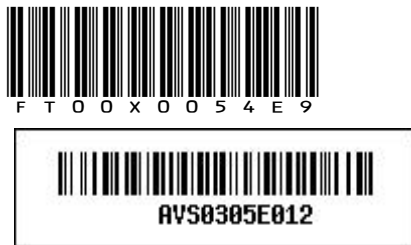
The switch serial number is provided on the serial number label, examples of which are shown here:

The serial number label is located as follows:

- Brocade 4100, 4900, and 7500/7500E – On the switch ID pull-out tab located inside the chassis on the port side on the left
- Brocade Encryption Switch, VA-40FC, 300, 5000, 5100, and 5300 – On the switch ID pull-out tab located on the bottom of the port side of the switch
- Brocade 7600 – On the bottom of the chassis
- Brocade 7800 – On the pull-out tab on the front left side of the chassis underneath the serial console and Ethernet connection and on the bottom of the switch in a well on the left side underneath (looking from front)
- Brocade 8000 – On the switch ID pullout tab located inside the chassis on the port side on the left and also on the bottom of the chassis
- Brocade 48000 – Inside the chassis next to the power supply bays
- Brocade DCX – Bottom right of the port side
- Brocade DCX-4S – Back, upper left under the power supply
